REPAIRING CLINKER PLYWOOD

When Ullapool's St Ayles skiff was seriously holed last winter, only epoxy could save her. Topher Dawson explains how.

With photographs by Chris Perkins

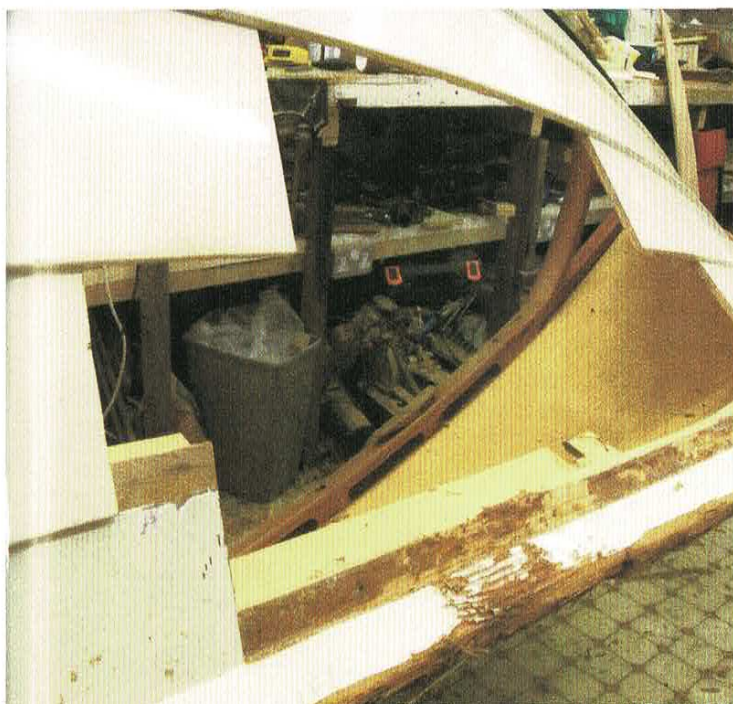
Above left: The first important stage of the repair is to remove the damaged planks carefully, which is made easier by supporting the hull on its side. **Above right:** With plywood graving pieces epoxied each side, the repaired plywood frame is now stronger than the original.

Having marked the ends of the old planks at 90° across, I took a deep breath and cut them with a jigsaw plunge cut. The part under the lap could be cut with a Japanese saw from outside or inside the boat. The bottom of the cut must only cut the plank above and not the one underneath. In traditional construction it helps to make this end cut at a frame so that the feather edge of the old plank scarph is supported but our boat has so few frames, it was not an option. When the planks were cut back to sound wood, the hole looked much bigger and the broken frame looked weak.

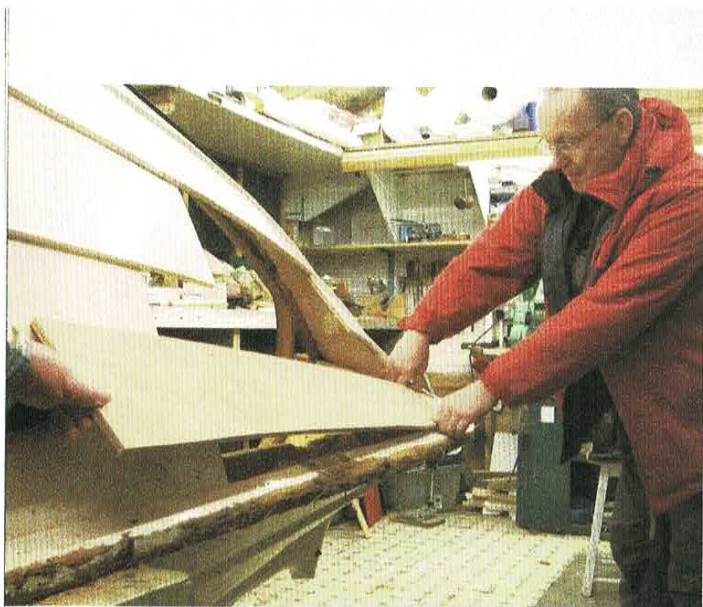
Above: Offering up the new plank. **Below:** Using an angle grinder to shape a new scarph in situ. **Bottom:** The plank in place, faired with a temporary batten until the epoxy has fully cured.

Once the boat was prepared to take the new planks, they were made to fit. In traditional construction, the damaged plank can often be kept in a good enough condition to copy its shape but with epoxy-glued laps, the plank has to come out in small pieces. Often the matching plank on the other side of the boat is undamaged and by bending a thin piece

of hardboard or ply on top of it and measuring sideways at intervals, the shape can be taken off. Otherwise the hole will have to be spiled. Cardboard is good for this, with broad tape stuck on the edges to give the exact outline. Of course, you have to add on the lap width to get the final shape. Checking the widths at the ends of the new piece against the scarphs of the hole is good too, in case your boat is not as symmetrical as she should be.

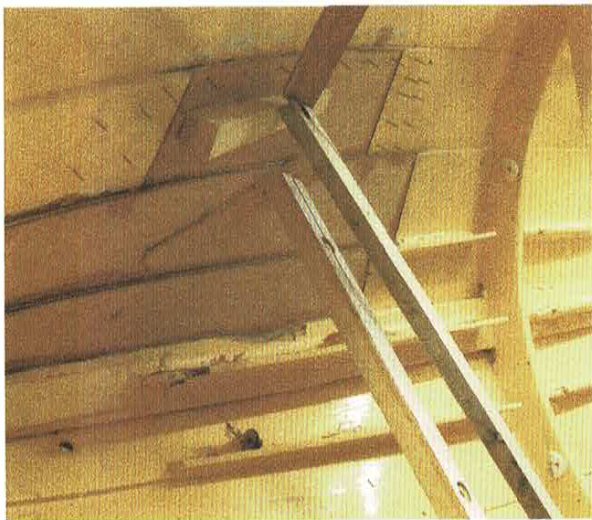
Top left: Props support the repair from the underside until the adhesive has set, when the temporary screws will be removed.
Top right: Another graving piece is scarphed into the keel.
Left: Making good! The ladies team spent hours building their arm muscles for the new season.
