Canobie – Lessons learned from the battery fire

Canobie - *electric motor arrangement*

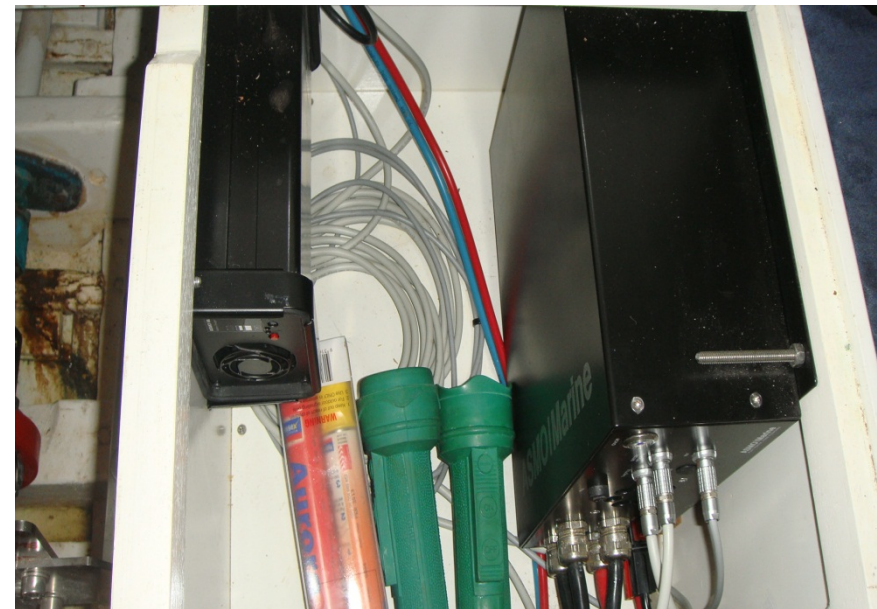
Compartment with charger and controller

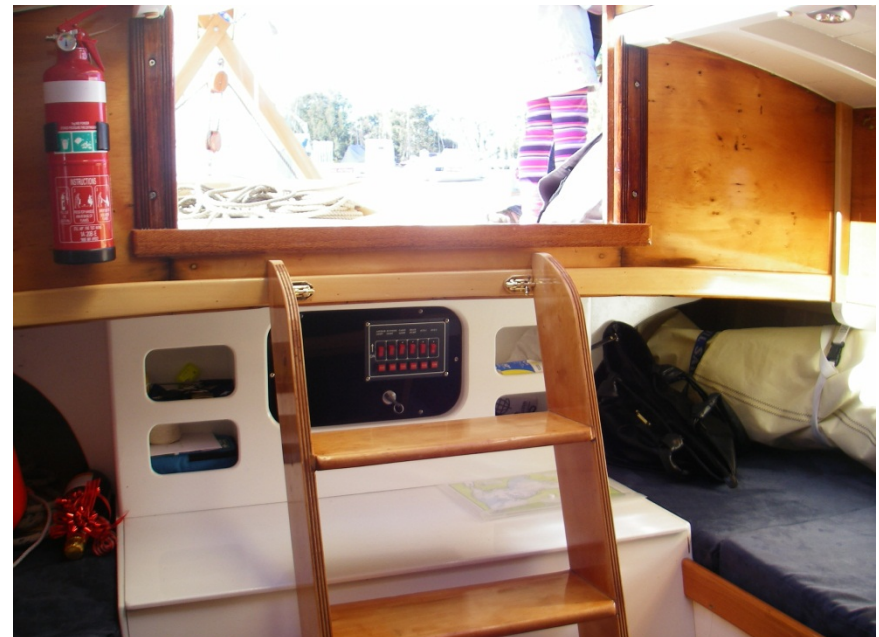
Unit concealed under cockpit

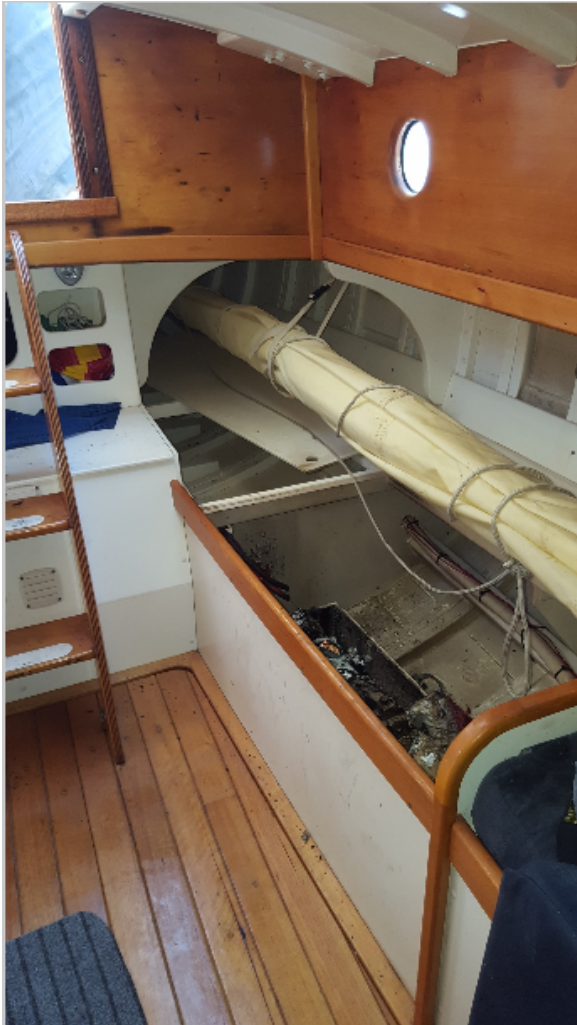
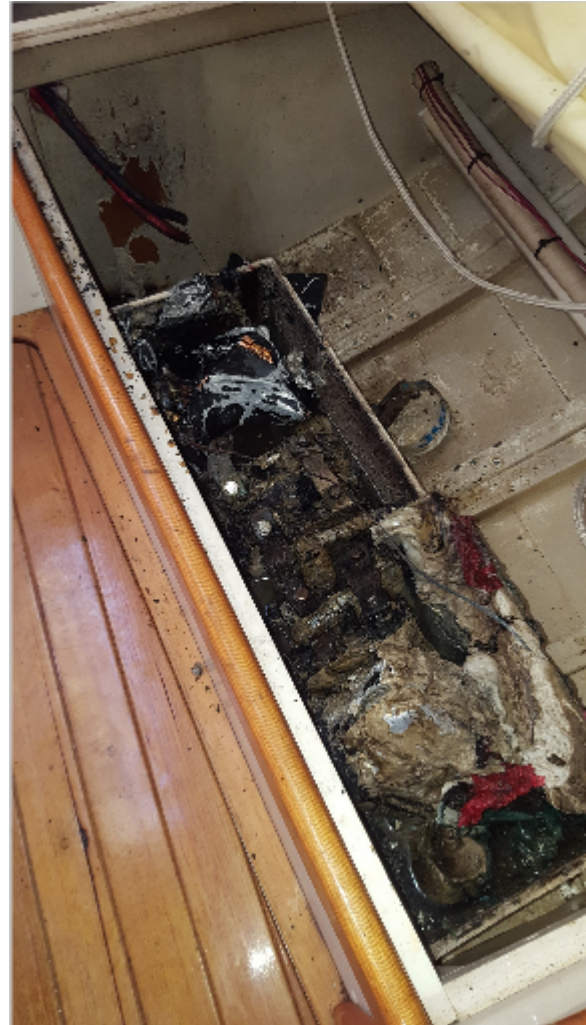
Canobie – lithium battery fire

- The final determination was that:
 1. The fire initiated in the 3rd cell of the port side battery bank, caused by a short between 2 leaves of the lithium-iron-phosphate medium (normally separated only by a 3micron thick inert sheet). It was most likely a tiny spec of foreign material trapped during manufacture.

2. The offending cell over-heated when left on charge, because the BMS did not shut off the solenoid and charging power. The BMS did not have an over-temperature detection function. Later models do.

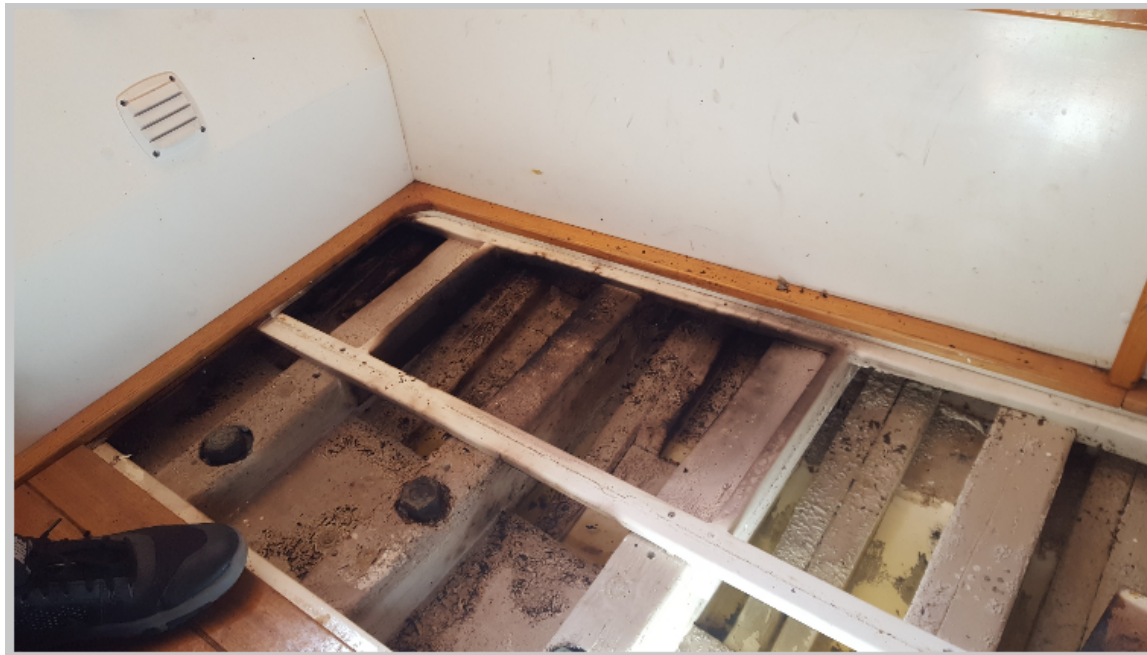
Canobie – fire damage

3. There is some conjecture as to whether or not the battery charger should also have shut off, at over-voltage.
- Club Marine agreed to meet all the expenses actually incurred in the subsequent repairs, without the scheduled excess amounts.
