REPAIRING CLINKER PLYWOOD

When Ullapool's St Ayles skiff was seriously holed last winter, only epoxy could save her. Topher Dawson explains how.

With photographs by Chris Perkins

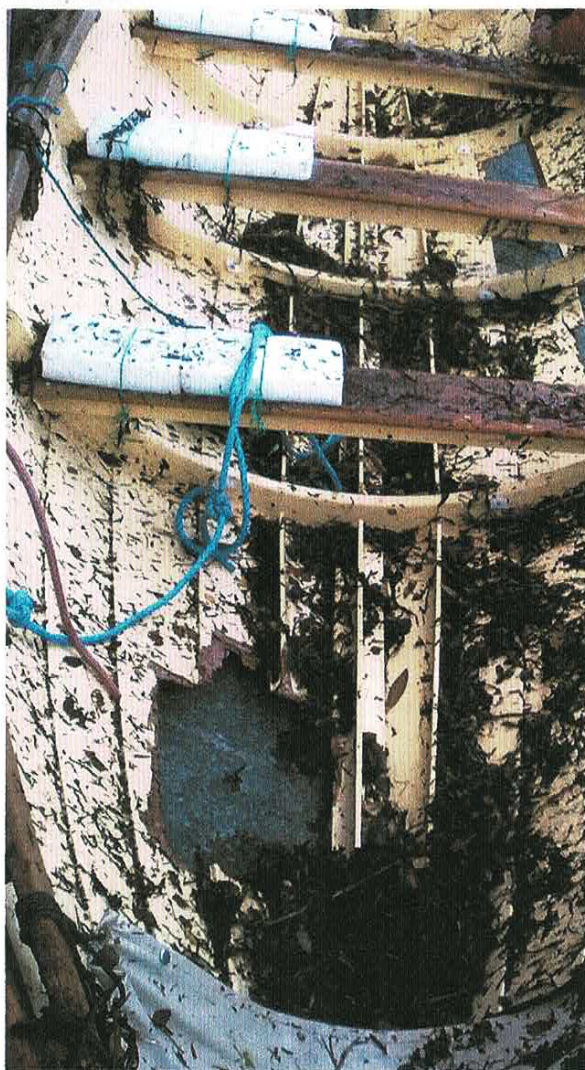
One early morning last November, *Ulla*, the lovely St Ayles Skiff, which members of the nascent Ullapool Coastal Rowing Club had built so carefully from a Jordan Boats kit – see W79 & W83 – was sucked down the steep slope above the beach, pulling out the boulder she was moored to and battered by an onshore gale coupled with a very high tide. She bashed against some rocks and a concrete drain outlet and was a sorry sight when we recovered her.

I felt sad and guilty, like a bad parent. She was so full of seaweed when we pulled her out, I feared large parts of the gunwale might be missing, but on cleaning her out, we found a hole about 30" by 24" (0.8 x 0.6m) covering three planks under the port stern quarter. There were two long gashes damaging 5 planks amidships in the starboard bilges, with one cracked frame.
